Nitrogen Inerting Field Case Study: Illinois Distribution Center

History and Background

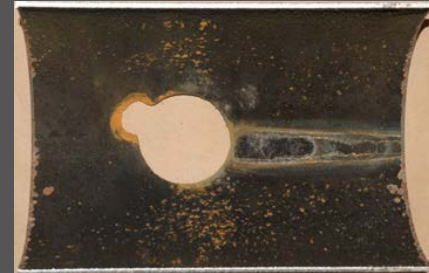
The assessment study determined that the root cause for corrosion within the systems was oxygen attack of the black steel piping. The majority of the damaged piping was found at the air/water interface adjacent to trapped pockets of air at the high points at the apex of the building. The mains also showed corrosion at the base of the mechanical tee at the riser nipple.

air trapped at top of main

1. Perform limited pipe replacement of the 2" branch lines on either side of the roof apex – approximately 50 linear feet per zone
2. Install ECS Protector Nitrogen Inerting Vents on each of the wet pipe zones
3. Install ECS Protector Nitrogen Injection Ports on each of the wet pipe risers
4. Perform nitrogen inerting of the fire sprinkler systems using the ECS nitrogen inerting protocol for wet pipe fire sprinkler systems
5. Use nitrogen cylinders to supply the necessary nitrogen gas for the inerting procedure on the fire sprinkler systems

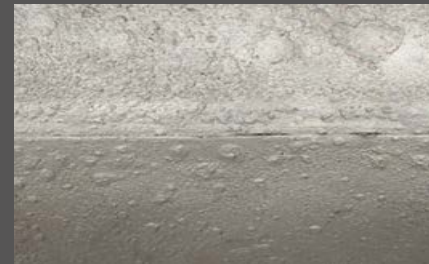
Corrosion on bottom of main

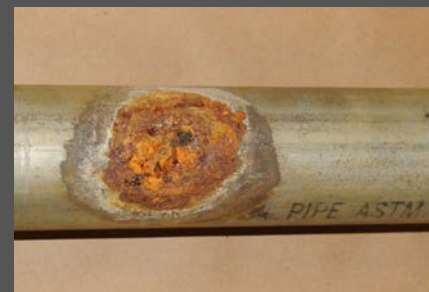
- Building age - 24 years
- Corrosion related leak history
 - Leaks occurring in branch lines at apex of building on the branch lines
 - Leaks occurring on the top side of the mains at the mechanical tee connection for the branch lines

exterior of branch line leak

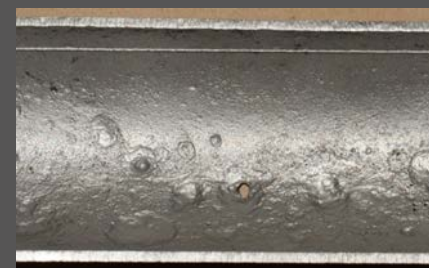
oxygen corrosion inside branch line
