Corrosion Assessment & Nitrogen Inerting Case Study: 90% Cost Savings at Illinois Distribution Center

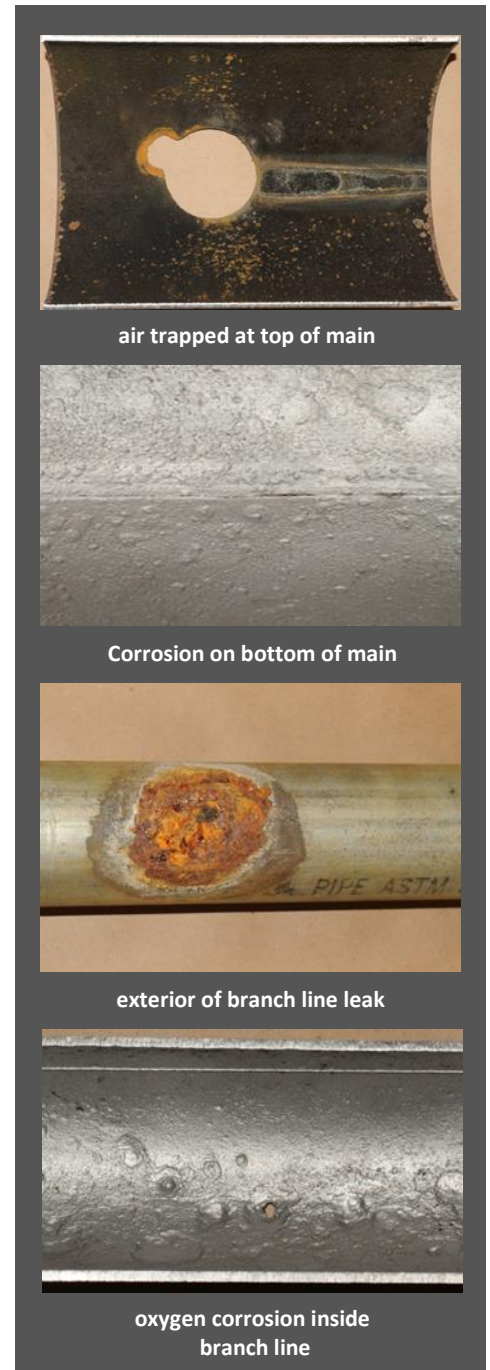
The assessment study determined that the root cause for corrosion within the systems was oxygen attack of the black steel piping. The majority of the damaged piping was found at the air/water interface adjacent to trapped pockets of air at the high points at the apex of the building. The mains also showed corrosion at the base of the mechanical tee at the riser nipple. Although bacteria were found within the fire sprinkler system, they were determined to be very minor contributors to the corrosion related leaks. Much of the fire sprinkler mains contained accumulations of corrosion by-product (iron oxide-hematite) solids.

1. Perform limited pipe replacement of the 2" branch lines on either side of the roof apex – approximately 50 linear feet per system
2. Install ECS Protector Nitrogen Inerting Vents on each wet pipe system
3. Install ECS Protector Nitrogen Injection Ports on each of the wet pipe risers
4. Perform nitrogen inerting of the fire sprinkler systems using the ECS nitrogen inerting protocol for wet pipe fire sprinkler systems
5. Use nitrogen cylinders to supply the necessary nitrogen gas for the inerting procedure on the fire sprinkler systems

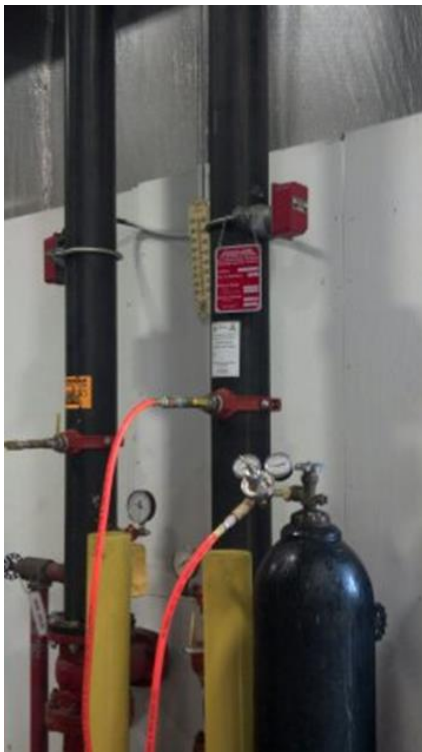
Pressurized cylinders provide nitrogen gas at sprinkler risers
