Nitrogen Inerting Field Case Study: California Home Improvement Center

History and Background

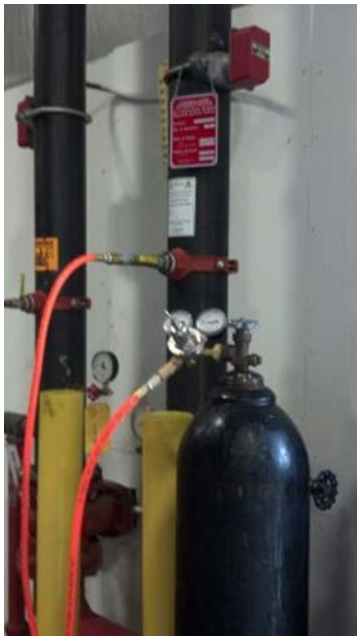
Pressurized cylinders provide nitrogen gas through injection ports at risers

1. Install ECS Protector Nitrogen Inerting Vents on each of the wet pipe zones
2. Install ECS Protector Nitrogen Injection Ports on each of the wet pipe risers
3. Perform nitrogen inerting of the fire sprinkler systems using the ECS nitrogen inerting protocol for wet pipe fire sprinkler systems
4. Use the nitrogen cylinders to supply the necessary nitrogen gas for the inerting procedure on the fire sprinkler systems
