## Dry Pipe Nitrogen Inerting (DPNI) – Case Histories Engineered Corrosion Solutions

### DPNI Case History No. 1 – Municipal Library in Indiana

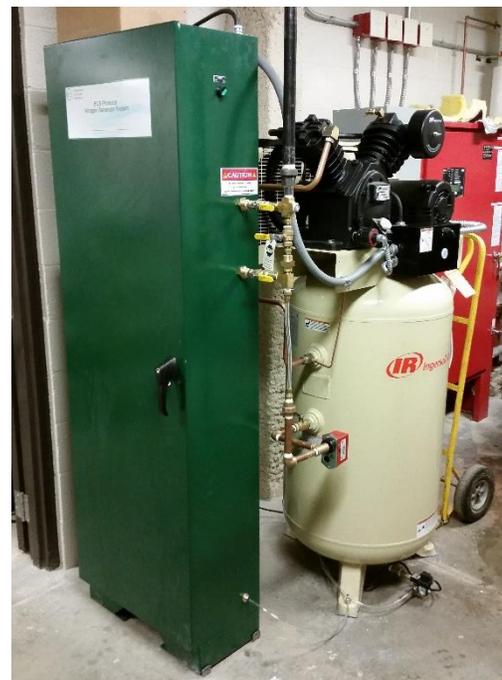
ECS PGEN-40 Nitrogen Generator  
Installed with Air Compressor

**Dry Pipe Nitrogen Inerting (DPNI)** – In March 2010 an ECS **PGEN-40 Nitrogen Generator** was installed to provide nitrogen pressure maintenance gas to the four (4) dry pipe sprinkler systems servicing the library. A single ECS Protector Dry Pipe Vent was installed on each of the fire sprinkler systems. All ECS nitrogen generators employ the patented “fill and purge” breathing technology to remove oxygen from the fire sprinkler piping and provide nitrogen gas for pressure maintenance within the piping.

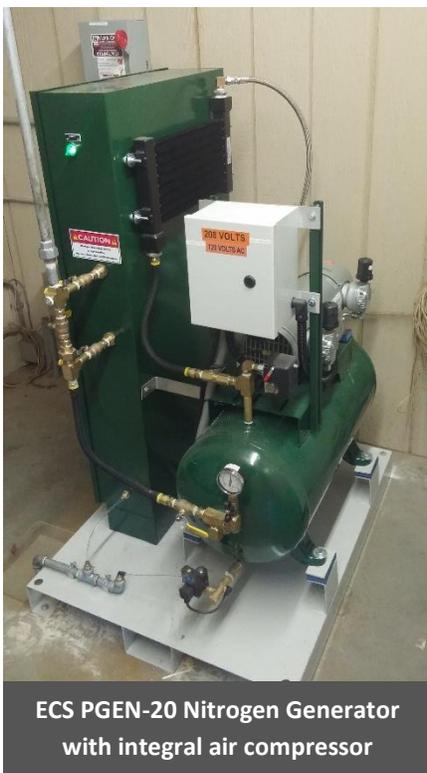
ECS PGEN-20 Nitrogen Generator  
with integral air compressor

**Dry Pipe Nitrogen Inerting (DPNI)** – In October 2011 an **ECS PGEN-20 Nitrogen Generator** was installed to provide nitrogen pressure maintenance gas to the dry pipe system. All ECS nitrogen generators employ the patented “fill and purge” breathing technology to remove oxygen from the fire sprinkler piping and provide nitrogen gas for pressure maintenance.

**Dry Pipe Nitrogen Inerting (DPNI)** – In July 2011 an **ECS PGEN-20 Nitrogen Generator** was installed to provide nitrogen pressure maintenance gas to the four (4) dry pipe systems servicing the condominium complex. All ECS nitrogen generators employ the patented “fill and purge” breathing technology to remove oxygen from the fire sprinkler piping and provide nitrogen gas for pressure maintenance.
