Project Case Study - Mission Critical Manufacturing

Project Type: Large Manufacturing Warehouse
Owner: Aerospace Equipment Manufacturer
Location: Los Angeles, CA
Sprinkler Systems: Twenty-five (25) wet systems
Nitrogen Introduced: October 2010

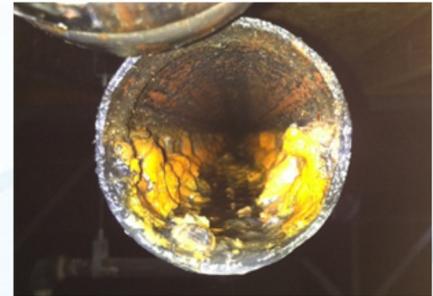
Corrosion at air/water interface

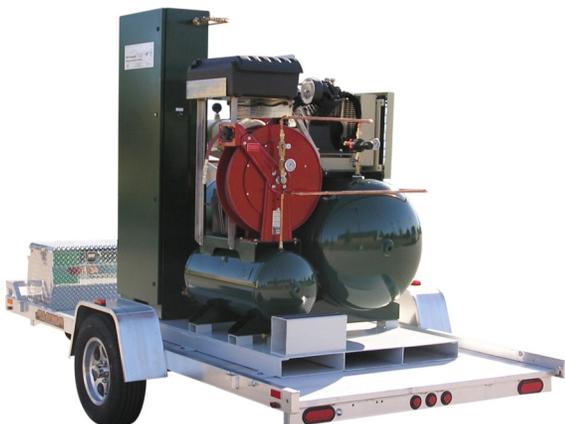
Portable nitrogen generator used at facility
