CORROSION IN AUTOMATIC SPRINKLER SYSTEMS

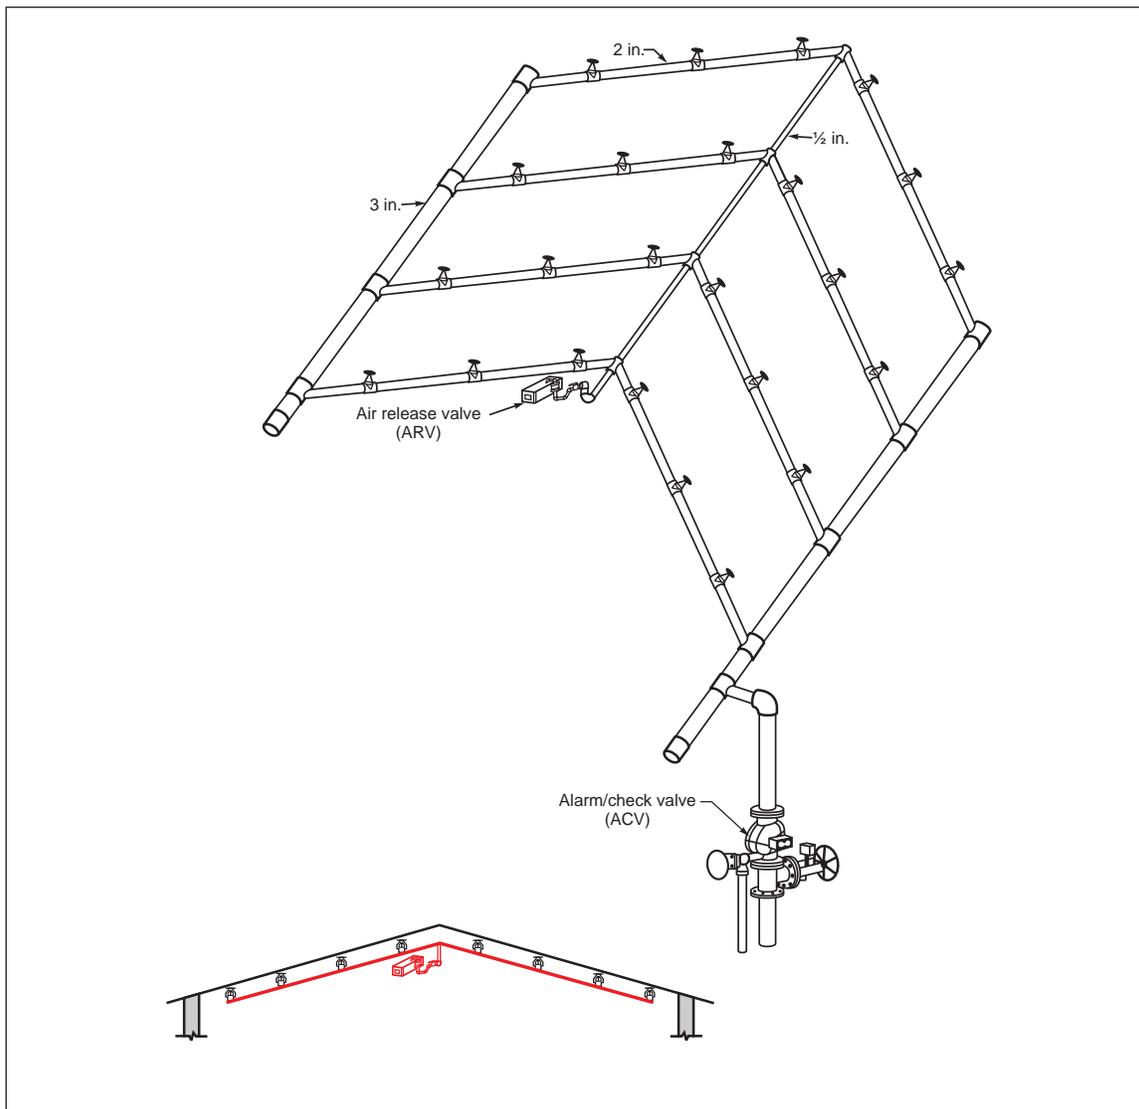
Fig. 1. Example of wet sprinkler piping arranged with an automatic air-release valve

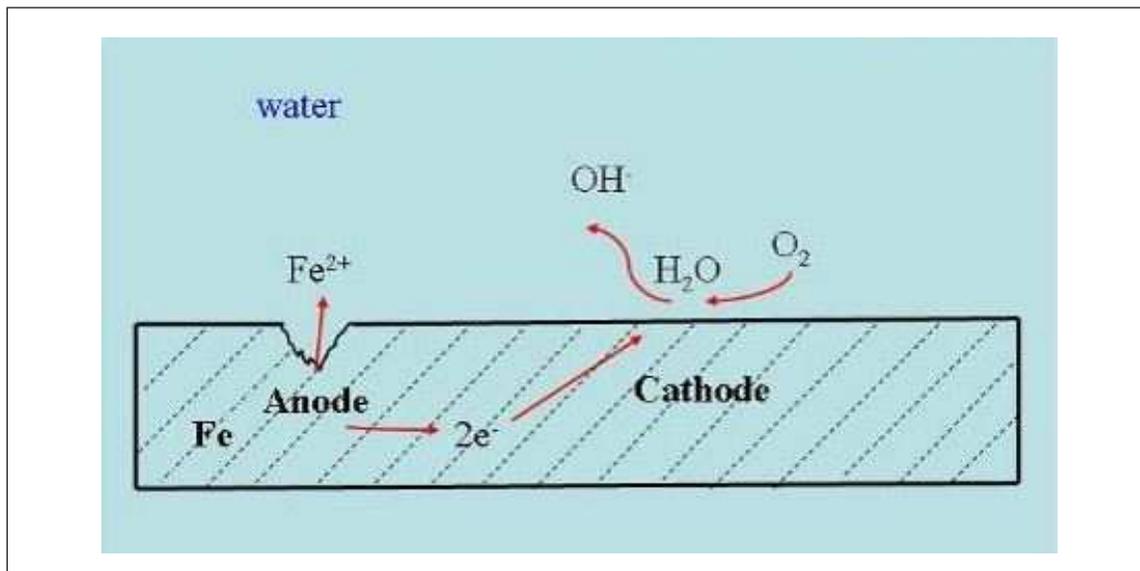
Figure 2 shows a schematic illustration of iron (Fe) corrosion in water. The Fe dissolves into Fe^{2+} at the anode and liberates electrons (e^-) reacting with O_2 and water to form hydroxide ions (OH^-) at the cathode (oxygen reduction reaction). In general, when a fire protection system (FPS) is supplied with sprinkler water containing oxygen, corrosion of steel or galvanized steel pipe (anodic reaction) in the FPS will occur and continue until oxygen in the water (cathodic reaction) is depleted by the corrosion reactions.

Fig. 2. Schematic illustration of iron (Fe) corrosion in water

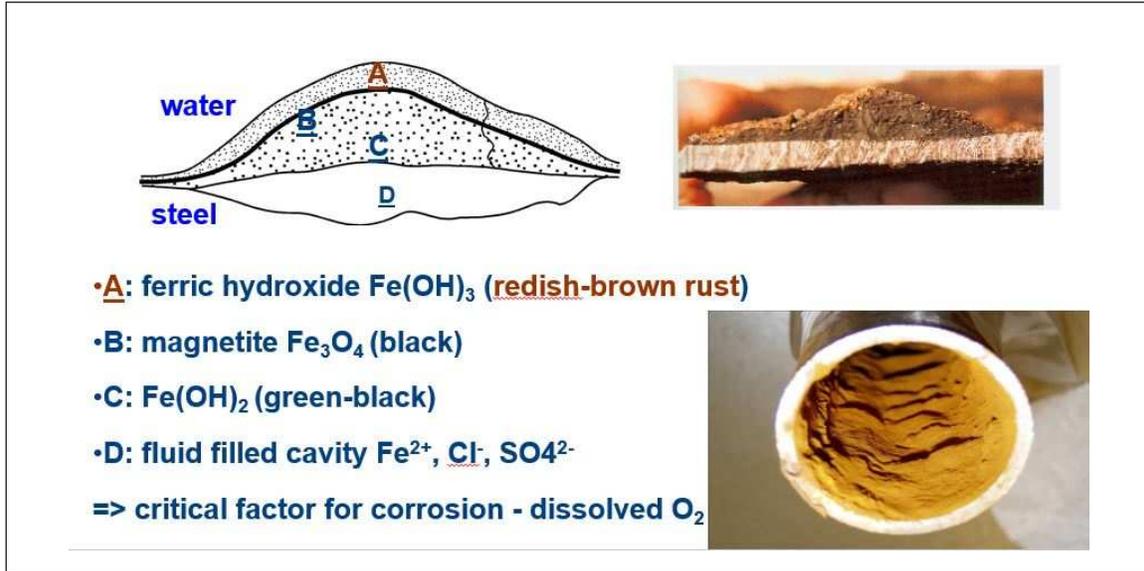
Many structural alloys corrode merely from exposure to moisture in air, but the process can be strongly affected by exposure to certain substances. Corrosion can be concentrated locally to form a pit or it can extend across a wide area, more or less uniformly corroding the surface (Figure 3).

Fig. 3. Development of corrosion

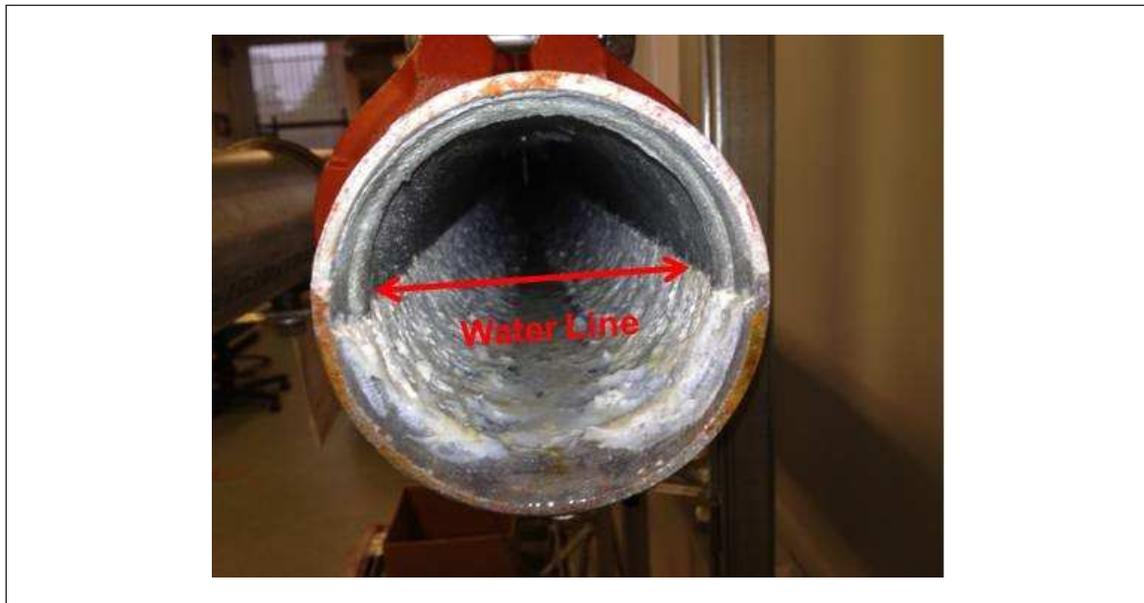
Figures 4a and 4b are photographs of galvanized steel pipe half-filled with tap water in house air (4a) and in compressed nitrogen (4b) after nearly six weeks' exposure. Whitish zinc corrosion products covered the bottom half of the house air-filled pipe in Figure 4a, but only limited zinc corrosion products covered the bottom half of the compressed nitrogen-filled pipe (Figure 4b). This result indicates that compressed nitrogen can reduce corrosion of galvanized steel pipe containing trapped water.

Fig. 4a. Galvanized steel pipe half-filled with tap water in house air after nearly six weeks' exposure

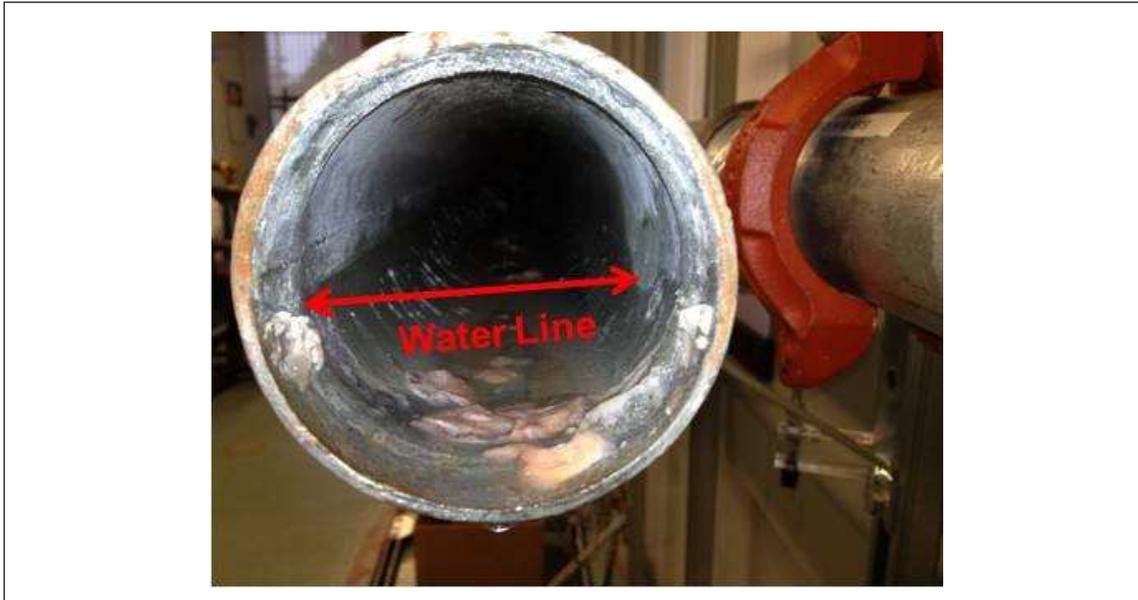
Fig. 4b. Galvanized steel pipe half-filled with compressed nitrogen after nearly six weeks' exposure

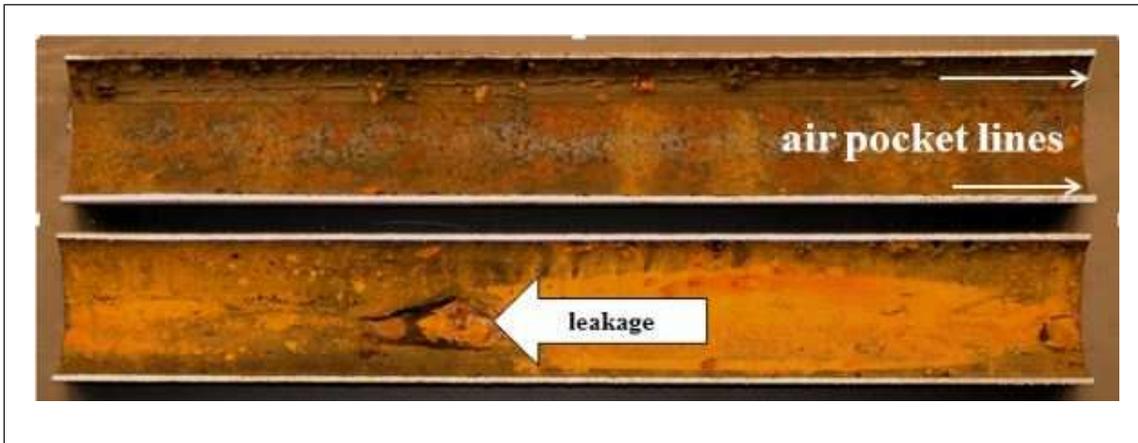
Figure 5 shows the section of a pipe in which the air gap filled approximately 40% of the volume in a wet pipe system, providing the oxygen source for steel pipe corrosion. The through-wall leakage site is indicated and the two parallel lines point to the air pocket boundary in the pipe. Note the significant tuberculation, corrosion, and deposit buildup in the bottom half of the pipe. The arrow points to a large tubercle, beneath which was the site of the leakage.

Fig. 5. Leakage section of a pipe where the air gap filled approximately 40% of the volume in a wet-pipe system

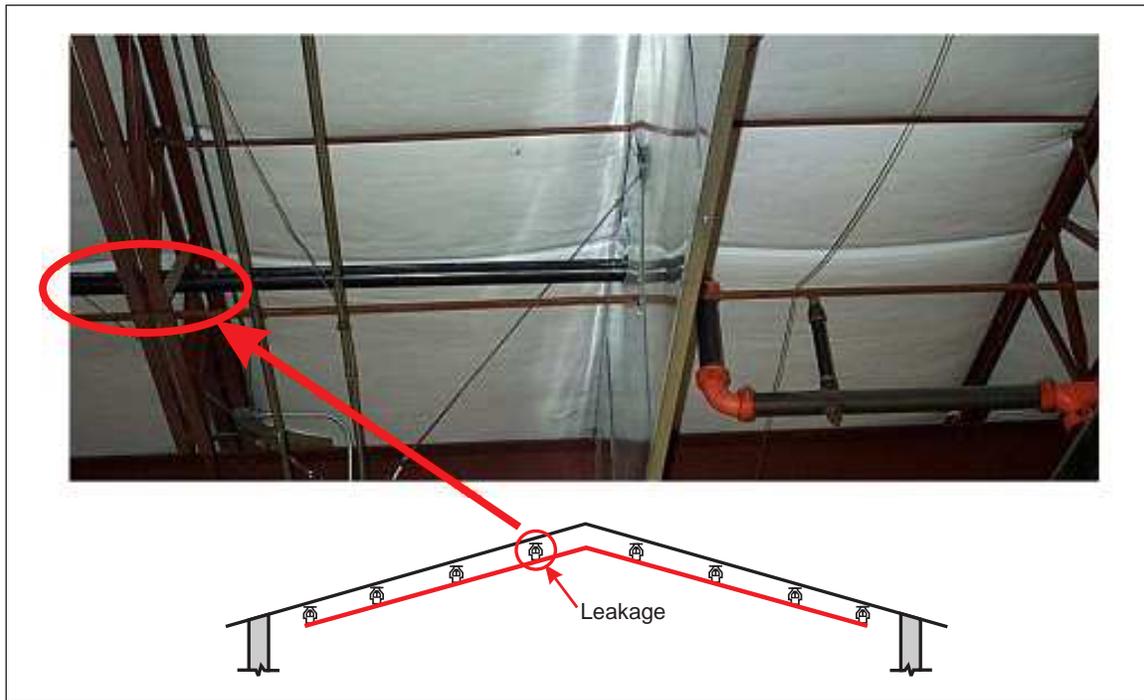
Figure 6 shows leakage sites of a wet pipe system due to trapped air. The leakage sites were at the left in the picture and near the roof bar joist as indicated. They were 10-15 ft to the left of the highest point in the system.

Fig. 6. Leakage sites of a wet pipe system due to trapped air

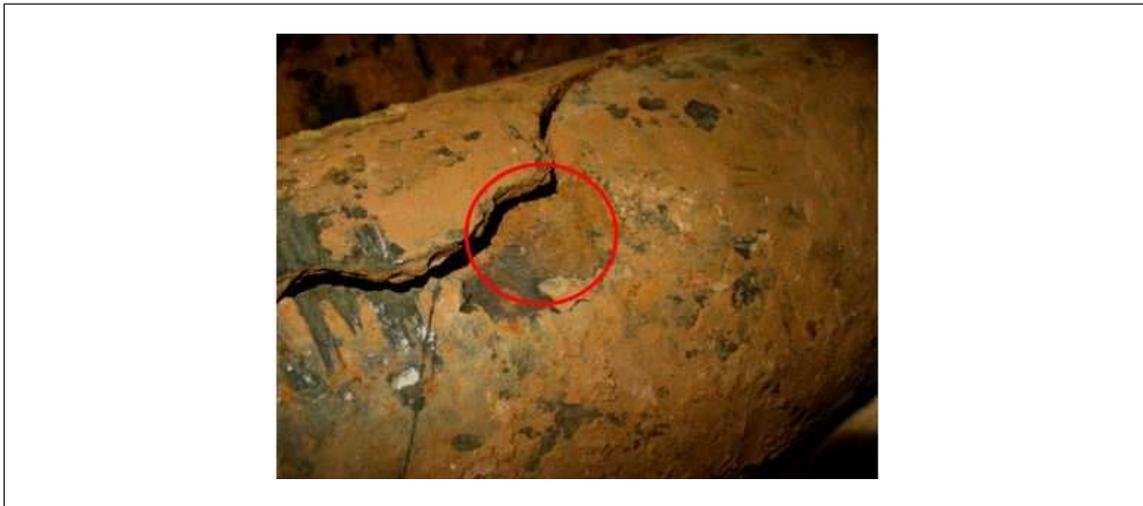
Figure 7 shows a ruptured underground water main (identified as gray cast iron, 8 in. [20.3 cm] diameter) with cement lining on its inside diameter. The circled area in Figure 7 shows graphitic corrosion on the outside surface of the main due to its exposure to mildly aggressive groundwater and soils. Generally, high moisture content in the surrounding soil is required for graphitic corrosion to occur.

Fig. 7. Ruptured underground water main (identified as gray cast iron, 8 in. [20.3 cm] diameter) with cement lining on its inside diameter

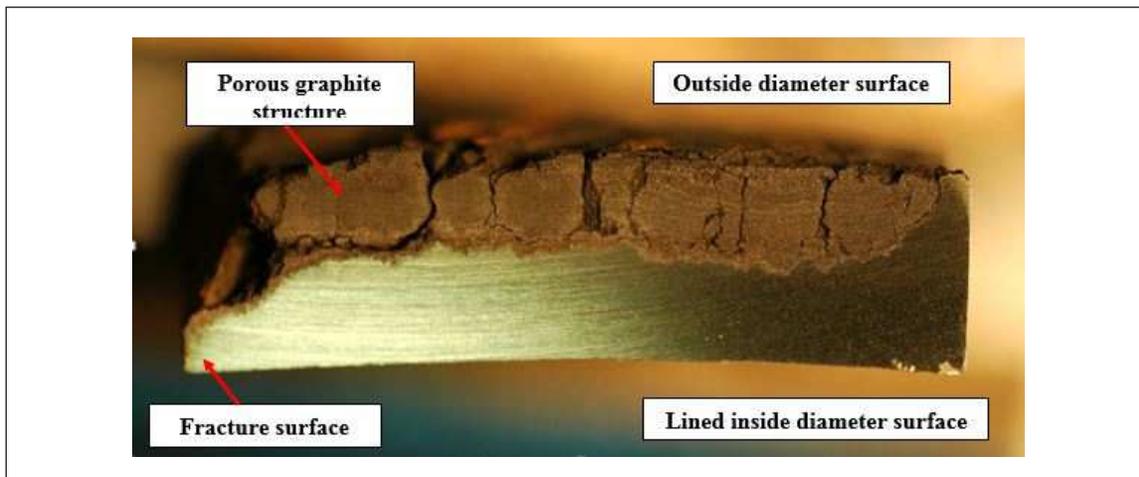
Figure 8 shows a cross section for part of the water main in Figure 7. It is noted that almost the entire wall thickness of the pipe has been penetrated by graphitic corrosion attack at the far left fracture surface, while the pipe's inside diameter surface with cement lining is in good condition.

Fig. 8. Cross section for part of the water main in Figure 7

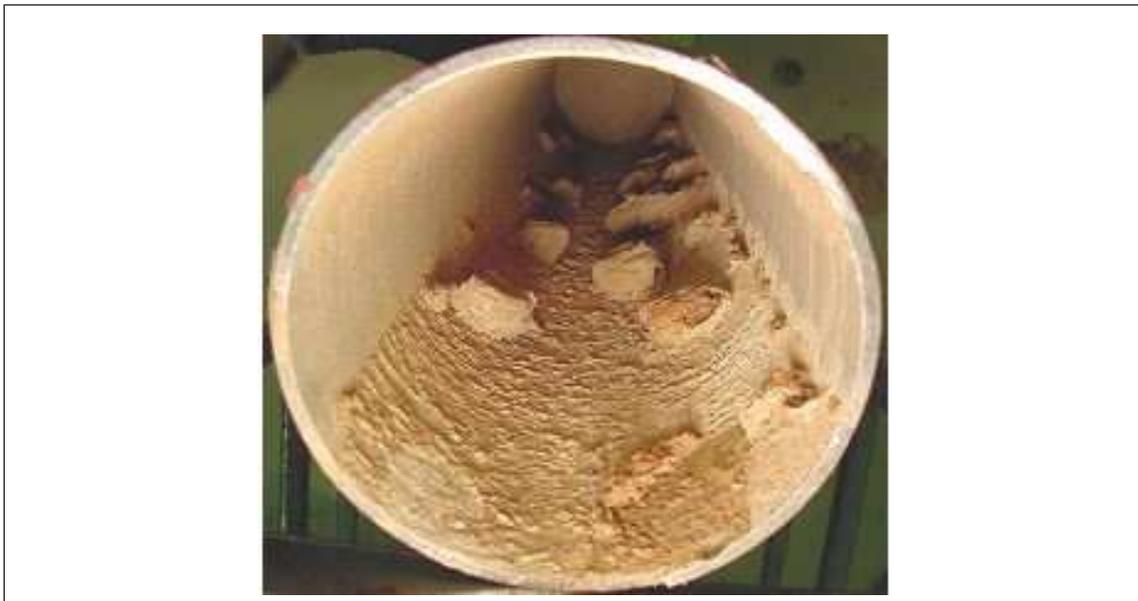
Figure 9a shows tubercles and and Figure 9b shows pinhole leakage (circled) in galvanized steel sprinkler pipe from dry-pipe systems.

Fig. 9a. Tubercles that formed inside a galvanized steel sprinkler pipe (4 in. [10 cm] diameter)

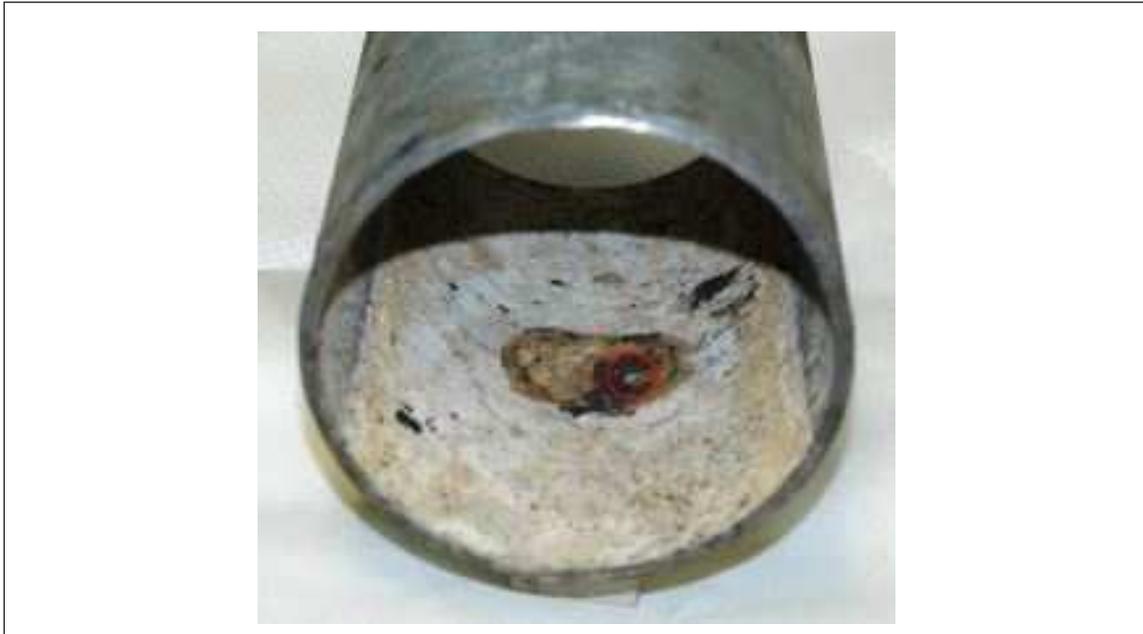
Fig. 9b. Corrosion at the base of a tubercle, which ultimately led to through-wall leakage

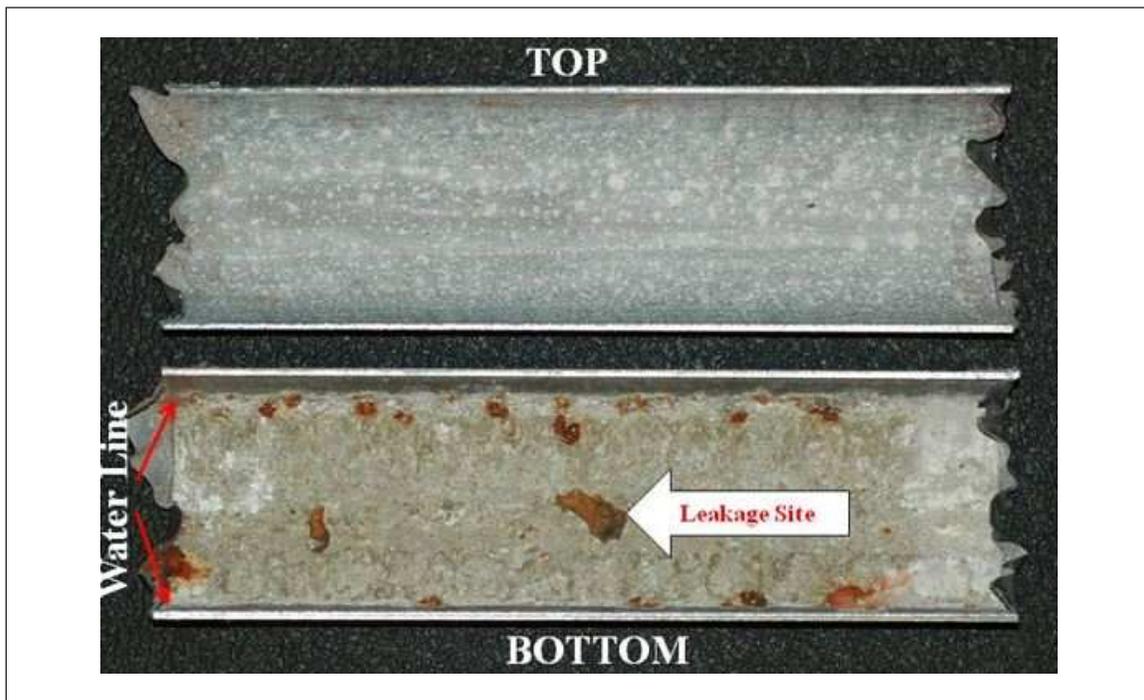
Figure 10 shows NPS 4 galvanized steel pipe (4.5 in. [11.4 cm] OD) with through-wall leakage. Residual water filled about 40% of the pipe's volume in service. Under the waterline, white rust (zinc corrosion) and well over a dozen reddish-brown tubercles of various sizes are evident on the bottom half of the pipe. The corrosion remains localized. The top half of the pipe is free of corrosion while the bottom half has significant corrosion.

Fig. 10. NPS 4 galvanized steel pipe (4.5 in. [11.4 cm] OD) with through-wall leakage

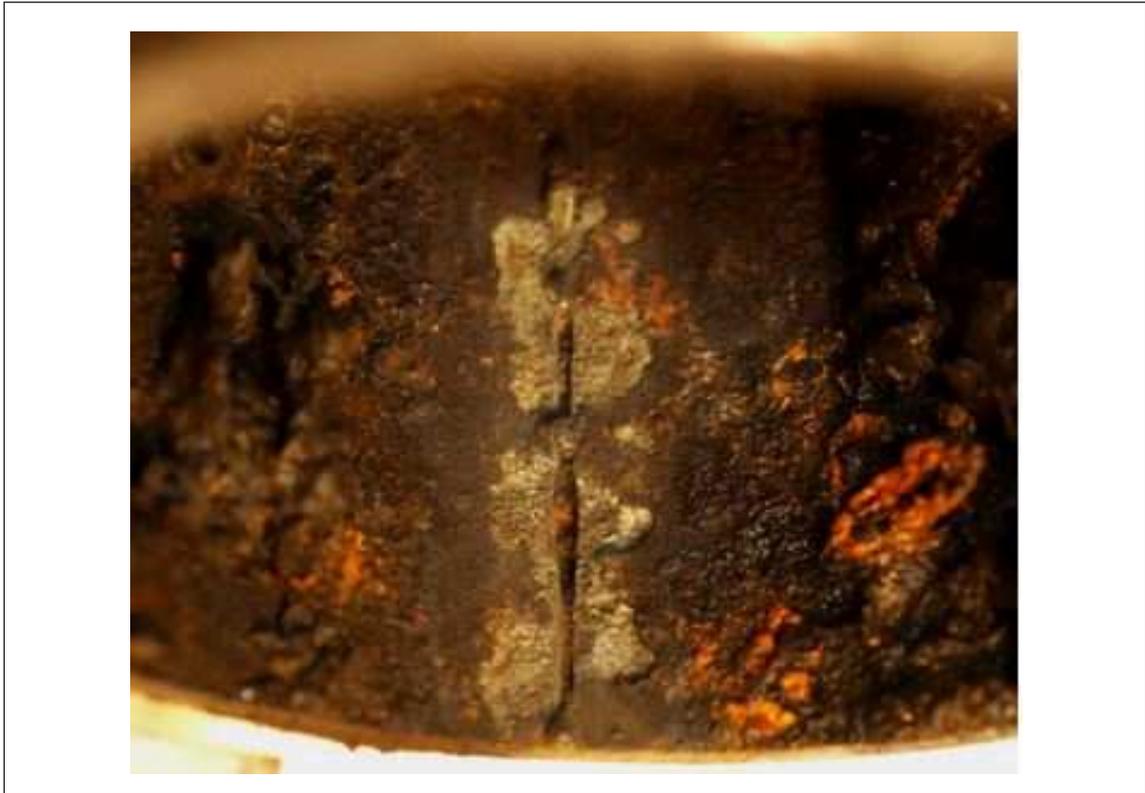
Figure 11b shows the waterside of the pipe in the region corresponding to the leakage site, after removal of corrosion products. Preferential attack surrounding the weld seam is severe.

Fig. 11b. Leakage on an NPS 2½ steel sprinkler pipe in a wet pipe system after removal of corrosion products; preferential attack surrounding the weld seam is severe

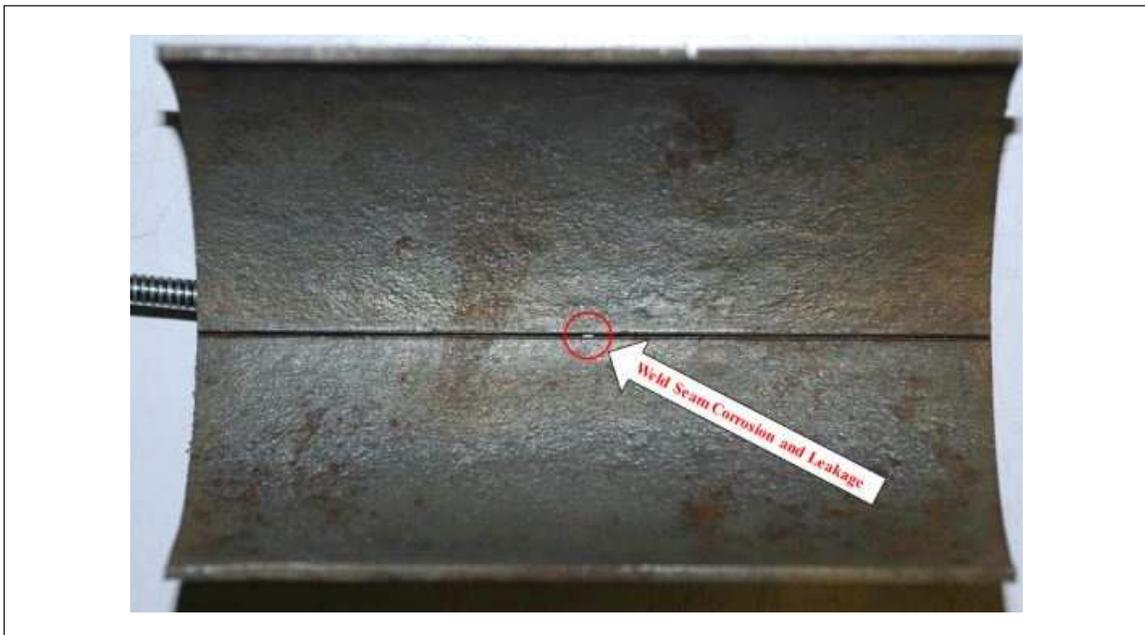
Figure 12 shows an example of preferential grooving corrosion on a pipe weld seam with a .04 in. (1 mm) pinhole leak in a wet-pipe system, after removing corrosion products inside an NPS 3 pipe.

Fig. 12. Preferential grooving corrosion on a pipe weld seam with a .04 in. (1 mm) pinhole leak in a wet pipe system, after removing corrosion products inside an NPS 3 pipe

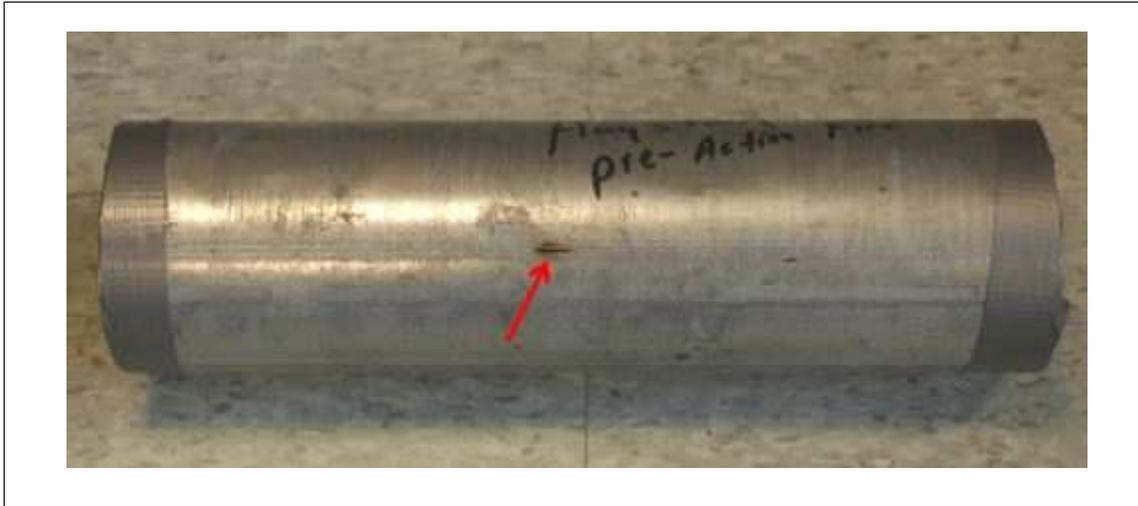
Figure 13 shows grooving corrosion of a longitudinal through-wall leakage in a galvanized steel pipe along its weld seam in a preaction system. The leak occurred beneath a large tubercle along the pipe's approximate 6 o'clock installed position. The arrow points a longitudinal through-wall leakage site on the pipe.

Fig. 13. Grooving corrosion of a longitudinal through-wall leakage in a galvanized steel pipe along its weld seam in a preaction

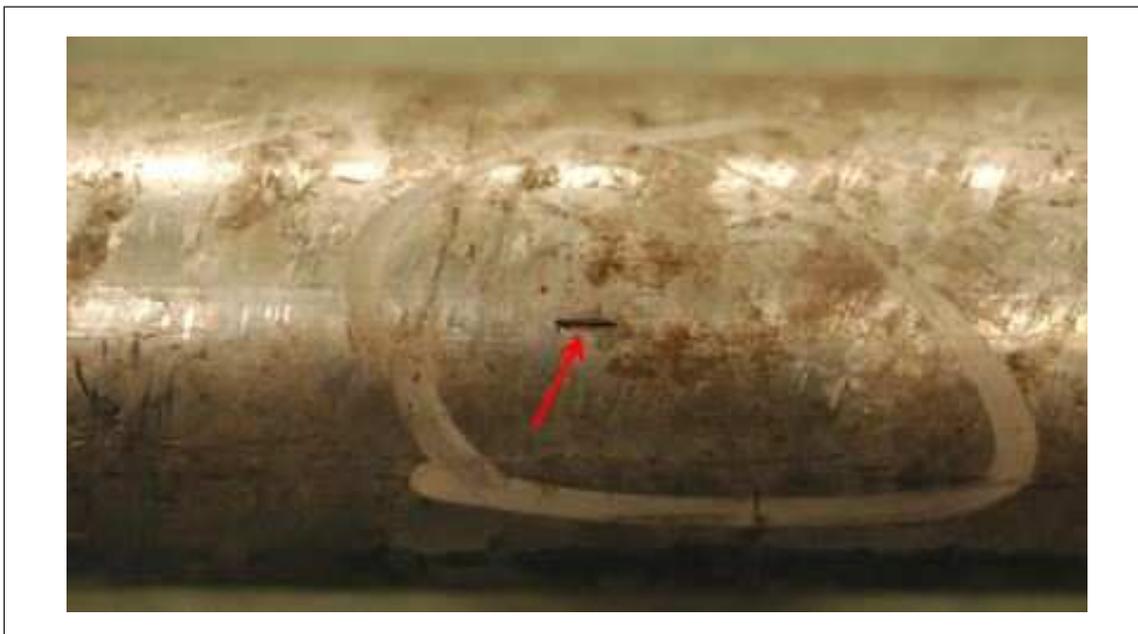
Figure 14 shows another preferential grooving corrosion attack surrounding the weld seam area for a preaction system, near the pipe's 6 o'clock (bottom) installed position.

Fig. 14. Preferential grooving corrosion attack surrounding the weld seam area for a preaction system, near the pipe's 6 o'clock (bottom) installed position

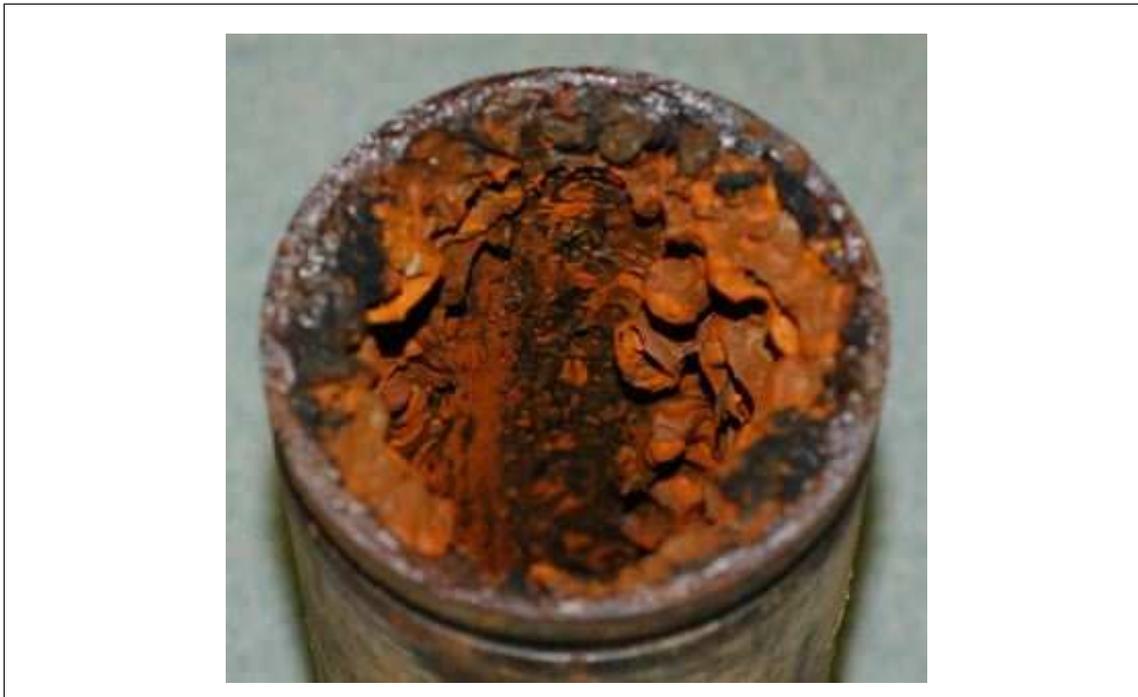
Figure 15 is an example of a 4 in. (10 cm) diameter corroded/leaking steel pipe with many tubercles formed inside the pipe. MIC caused by SRB was identified to be a likely contributing factor to the corrosion based on testing results of SRB immunoassay, lead acetate sulfide tests, water chemistry analyses, and corrosion/metallurgical evidence.

Fig. 15. Corroded steel pipe with many tubercles inside
