Dry Pipe Nitrogen Inerting (DPNI) – Case Histories

Engineered Corrosion Solutions

DPNI Case History No. 1 – Municipal Library in Indiana

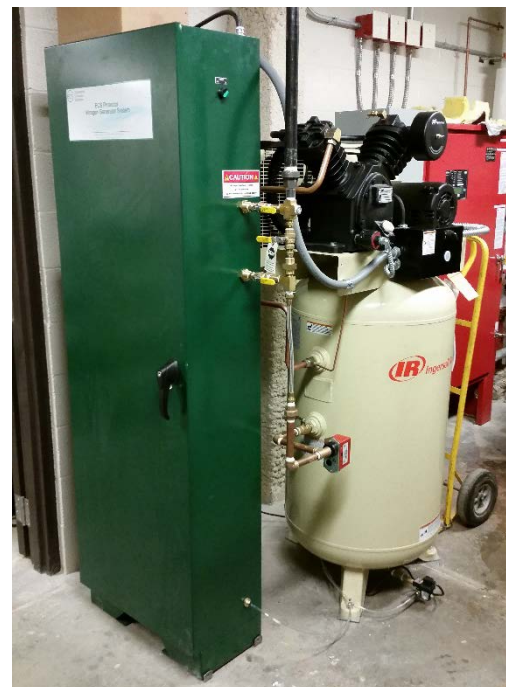
ECS PGEN-40 Nitrogen Generator
Installed with Air Compressor

Dry Pipe Nitrogen Inerting (DPNI) – In March 2010 an ECS **PGEN-40 Nitrogen Generator** was installed to provide nitrogen pressure maintenance gas to the four (4) dry pipe sprinkler systems servicing the library. A single ECS Protector Dry Pipe Vent was installed on each of the fire sprinkler systems. All ECS nitrogen generators employ the patented “fill and purge” breathing technology to remove oxygen from the fire sprinkler piping and provide nitrogen gas for pressure maintenance within the piping.

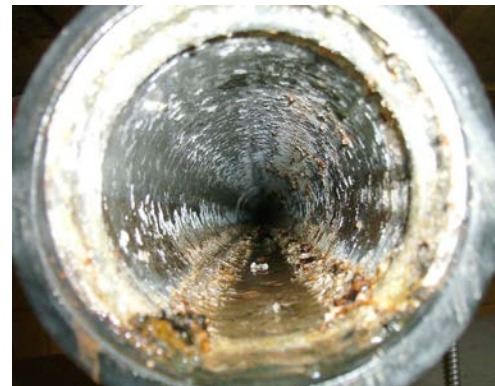
Background – 100,000 square foot data center originally built and opened in 2002 with double interlock preaction fire sprinkler systems to protect the data halls. Galvanized steel piping was used for all of the preaction fire sprinkler systems. After 8 years of service leaks began to develop in the 3” galvanized schedule 10 main piping within the facility. All of the leaks occurred within the main line piping under accumulations of trapped water. The metal loss was characterized by highly localized attack with many deep singular round bottomed pits beneath the trapped pools of water.

A corrosion assessment survey was performed in July 2010 to determine the extent of damage within the fire sprinkler piping. The video scoping results indicated that there was extensive damage due to oxygen corrosion within the mains at the trapped water locations throughout the facility. The schedule 40 galvanized branch lines exhibited minor corrosion and did not contain much trapped water. The average corrosion pit depth from the pipe samples that were extracted from the facility was 45% wall penetration.

**Corroded Galvanized Main
with Trapped Water**

Dry Pipe Nitrogen Inerting (DPNI) – In early 2011 the client elected to install the ECS nitrogen generator and employ the patented “fill and purge” breathing technology to remove oxygen from the fire sprinkler piping and provide nitrogen gas for pressure maintenance. The fill and purge breathing process is the only approach that can effectively remove oxygen from the system piping before it can react with the pipe metal. A single **ECS PGEN-20 Nitrogen Generator** was installed and commissioned to handle the five (5) preaction sprinkler systems within the facility.

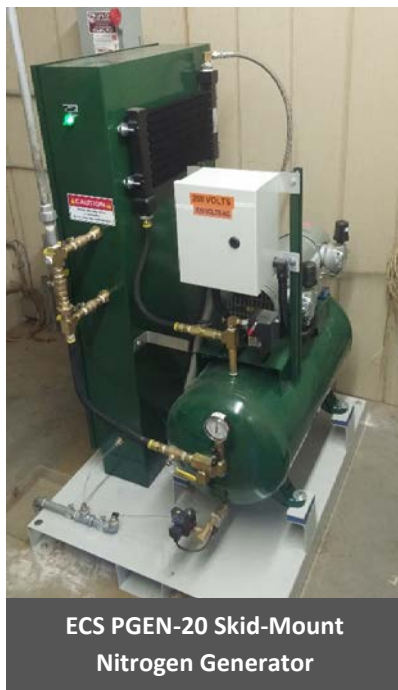
**ECS PGEN-20 Skid-Mount
Nitrogen Generator**

Dry Pipe Nitrogen Inerting (DPNI) – In October 2011 an **ECS PGEN-20 Nitrogen Generator** was installed to provide nitrogen pressure maintenance gas to the dry pipe system. All ECS nitrogen generators employ the patented “fill and purge” breathing technology to remove oxygen from the fire sprinkler piping and provide nitrogen gas for pressure maintenance.

Dry Pipe Nitrogen Inerting (DPNI) – In July 2011 an **ECS PGEN-20 Nitrogen Generator** was installed to provide nitrogen pressure maintenance gas to the four (4) dry pipe systems servicing the condominium complex. All ECS nitrogen generators employ the patented “fill and purge” breathing technology to remove oxygen from the fire sprinkler piping and provide nitrogen gas for pressure maintenance.
