Nitrogen Inerting Field Case Study: Illinois Distribution Center

History and Background

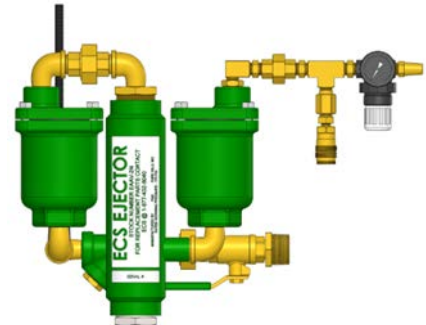
ECS Ejector Nitrogen Inerting Vent

1. Perform limited pipe replacement of the 2" branch lines on either side of the roof apex – approximately 50 linear feet per zone
2. Install ECS Protector Nitrogen Inerting Vents on each of the wet pipe zones
3. Install ECS Protector Nitrogen Injection Ports on each of the wet pipe risers
4. Perform nitrogen inerting of the fire sprinkler systems using the ECS nitrogen inerting protocol for wet pipe fire sprinkler systems
5. Use nitrogen cylinders to supply the necessary nitrogen gas for the inerting procedure on the fire sprinkler systems

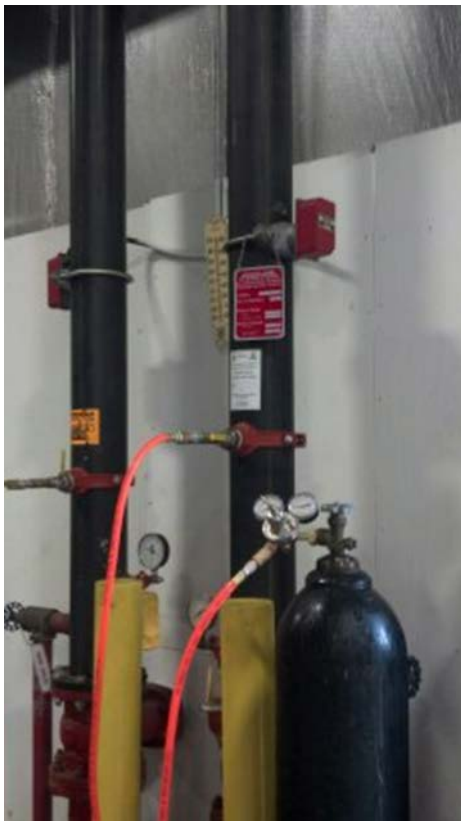
Pressurized cylinders provide nitrogen gas through injection ports at risers
