White Paper

Managing Fire Sprinkler System Risk in a Mission Critical Data Center Setting

(October 2012)

Important Questions to Ask

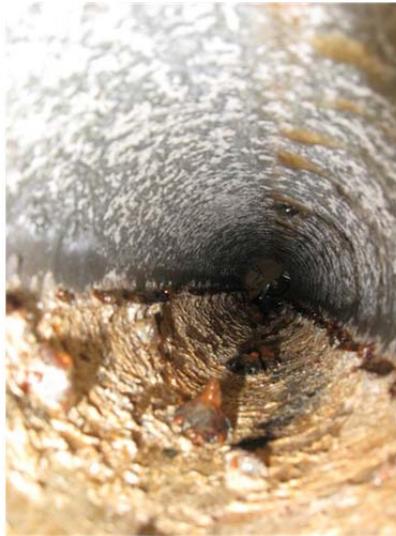
The National Fire Protection Association (NFPA) requires that all dry and preaction fire sprinkler systems be hydrostatically tested before they are commissioned for service. The result of this necessary exercise is that there are always small pools of trapped water in the fire sprinkler piping. It is virtually impossible to drain out all of the water after the test. Additional amounts of water are added to the piping during periodic system testing (also required by the NFPA). A third source adds moist air each time the pressure maintenance compressor clicks on to keep the piping pressurized. The moisture in the air eventually condenses to produce condensate water within the piping. Until the 2007 edition of the installation standard for fire sprinkler systems, NFPA 13 did not require preaction fire sprinkler systems be “pitched” to allow draining of trapped water from the piping. This means that most preaction systems

installed before enforcement of the 2007 edition of NFPA 13 are not pitched and invariably contain significant amounts of trapped water.

Corrosion cannot occur without liquid water. In the case of preaction fire sprinkler pipes, all of the necessary elements are present: the steel piping, water and plenty of oxygen. Corrosion is inevitable in these systems and depending on the number of trapped pools of water, the amount of water and the amount of oxygen the corrosion rates can be quite high.

Evidence of trapped water in piping

One other ironic twist in the corrosion equation is that any pin holes that develop are always in intimate contact with the pool of water that formed them. Further, they are almost always located at the 6 o'clock position in the fire sprinkler piping. The net result is that the corrosion hole almost always delivers a significant quantity of water into the protected space when the leak finally breaks open. The pressurized air pushes rusty water through the pin hole as a fine mist propelled by the pressurized air in the system onto the electrical circuitry of the servers below.

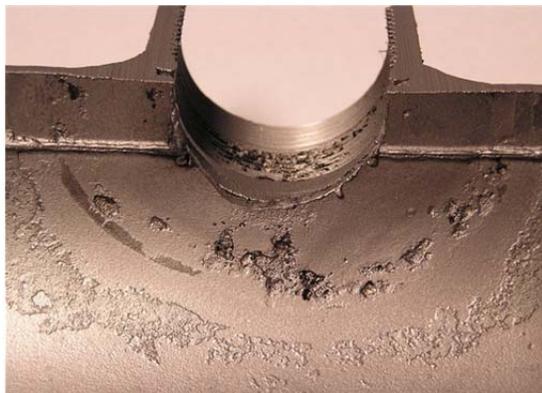
Anodic hot spot due to weld-o-let installation

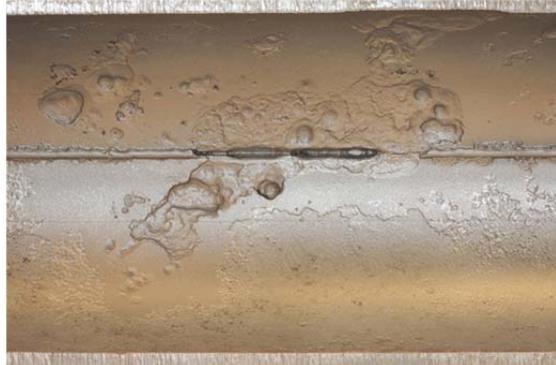
Another factor contributing to corrosion related leaks is the lack of heat annealing of the weld seam on fire sprinkler piping. The current ASTM Standards for the fire sprinkler industry do not require that the weld seams be heat annealed, the result is that the piping is subject to “knife cut” corrosion wherein the weld metal and the heat affected zone adjacent to the weld

Knife cut corrosion on submerged weld seam
(galvanized steel pipe)

corrode preferentially to the rest of the pipe. If the weld seam happens to end up installed under trapped water, failures in schedule 10 galvanized steel piping have occurred in as little as 12 months.
