ECS Corrosion Assessment Program for Water-Based Fire Sprinkler Systems

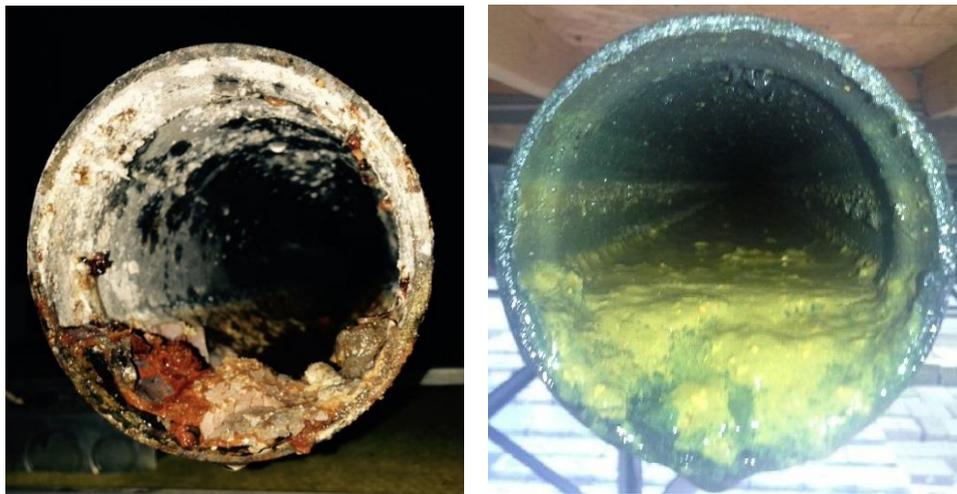
Left: galvanized pipe in dry system with trapped water
Right: black steel pipe in wet system with trapped air
